Inspector Name Jim Michelmores
Company Name JM's Home Inspections
Company Address 11637 Boom Pointer Way
City Gold River **State** CA **Zip** 95670
Phone 916-216-6612 **Fax** 916-635-1366
E-Mail jmichelmores@sbcglobal.net
File Number Sample report
Amount Received \$400.00 Through Escrow

Home Inspection Report

1234 Unknown Drive
Anywhere, CA 00000

Prepared for: John Doe

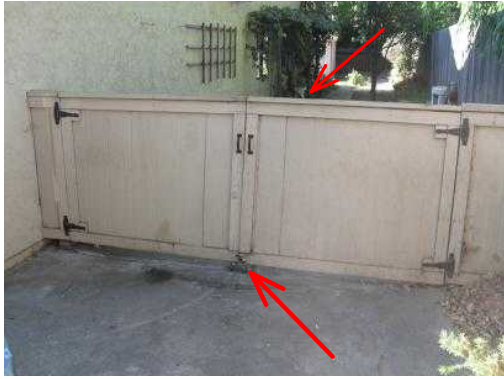
The right side gate is damaged and deteriorated. There is a pad lock on the right side gate.

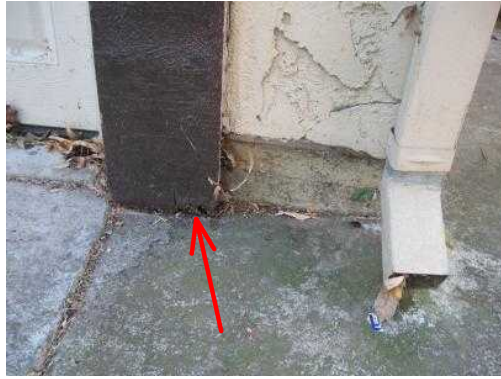
Wood deterioration noted to the trim, at right base of right/front roll-up garage door.

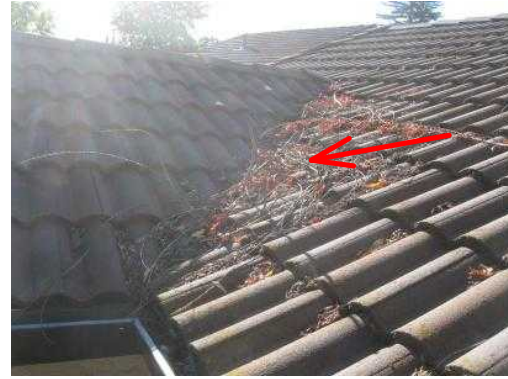
Debris located in metal valleys. Recommend cleaning the valley areas, for proper roof drainage.

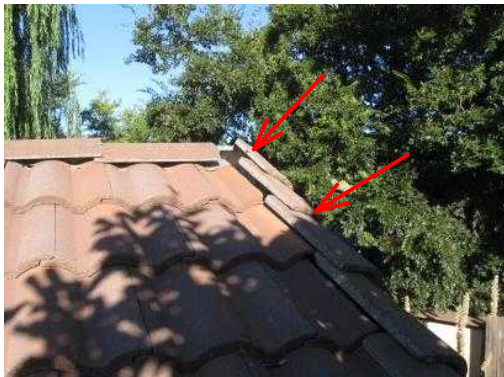
Loose front ridge and edge caps noted, above the garage. Repair, as required.

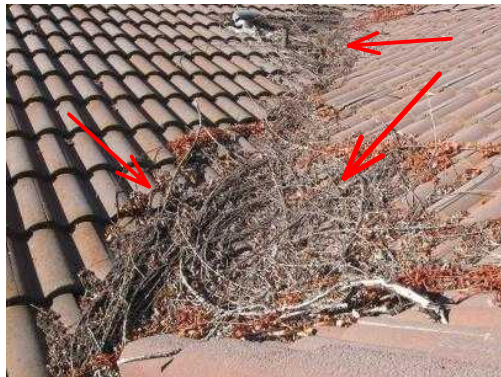
Debris located in metal valleys. Recommend cleaning the valley areas, for proper roof drainage.

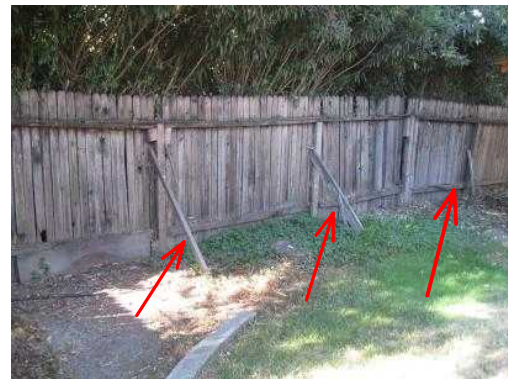
Rear fence sections are being held up by boards. Repair, as required.

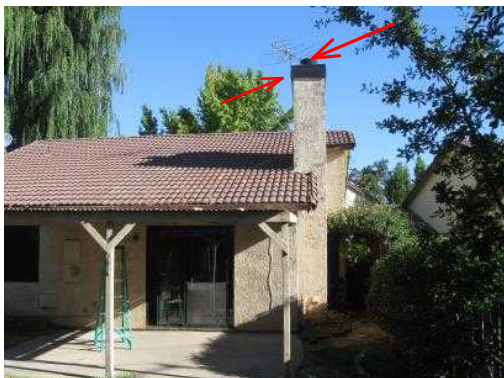
Chimney has a cap and spark arrester. Antenna is mounted to chimney, causing unnecessary stress.

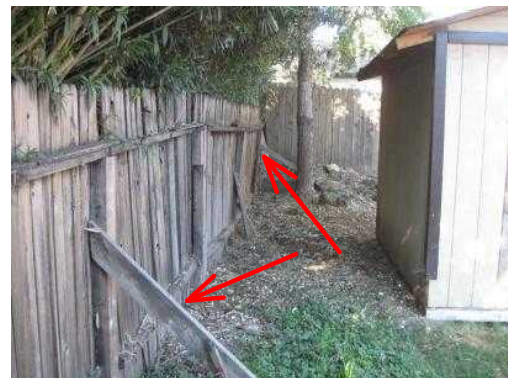
Rear fence sections are being held up by boards. Right/rear fence section is broken/damaged.

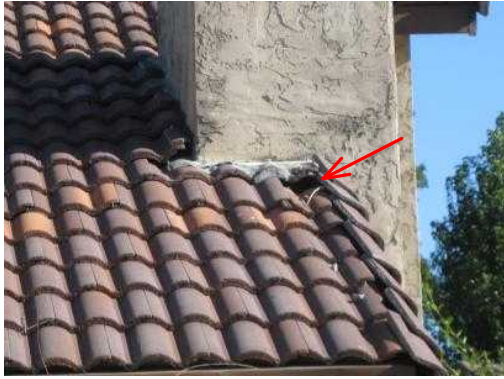
Slipped down rear roof tile noted, at base area of chimney. Repair, as required.

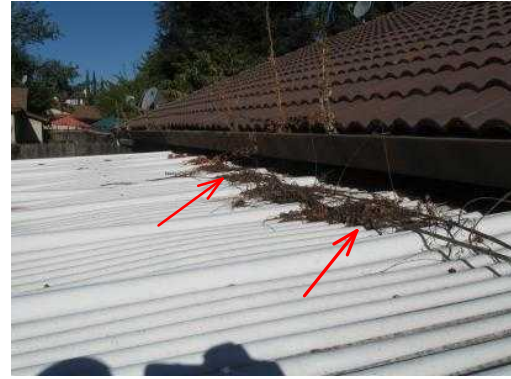
Debris on patio roof. Keep clean, to assist in preventing damage.

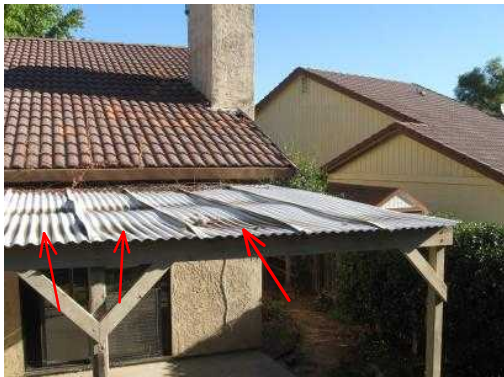
Loose/bent top patio cover fiberglass panels noted. Repair, as necessary.

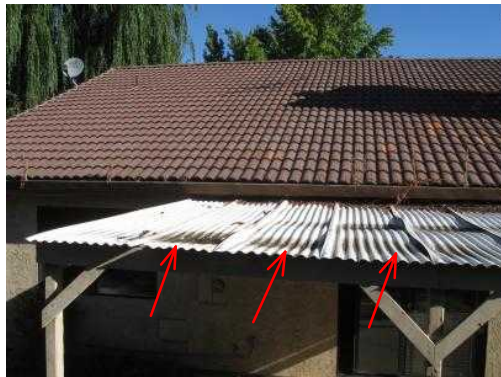
Loose/bent top patio cover fiberglass panels noted. Repair, as necessary.

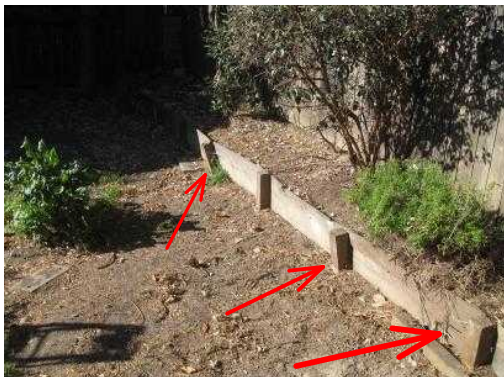
Wood timber retaining wall at right side is leaning and posts are deteriorated.

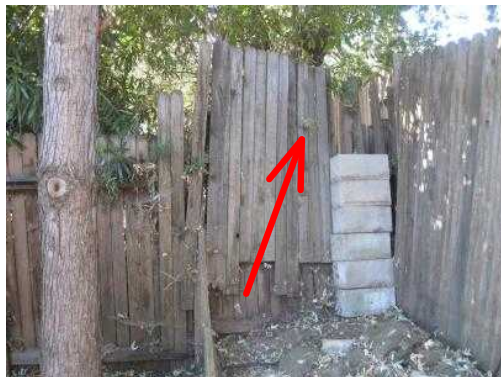
Right/rear fence section is broken/damaged. Repair/replace fence sections, as necessary.

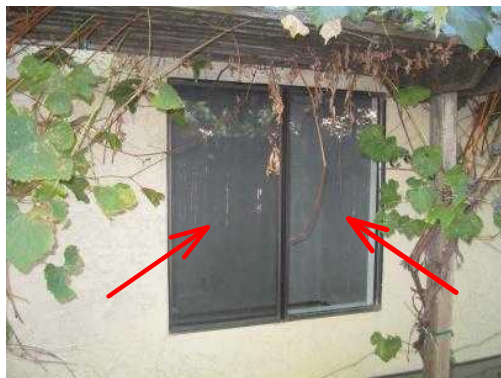
Failed seal noted at right side/middle bedroom window. Repair, as necessary.

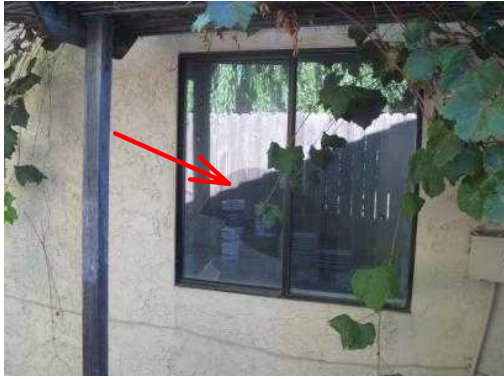
Cracked/broken window noted at right/front bedroom ; repair, as required.

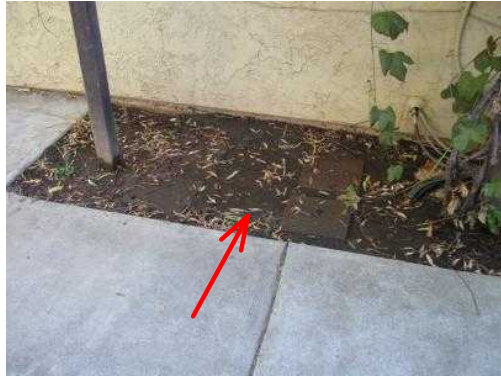
Standing water noted, at right side of house, near the exterior heat pump unit.

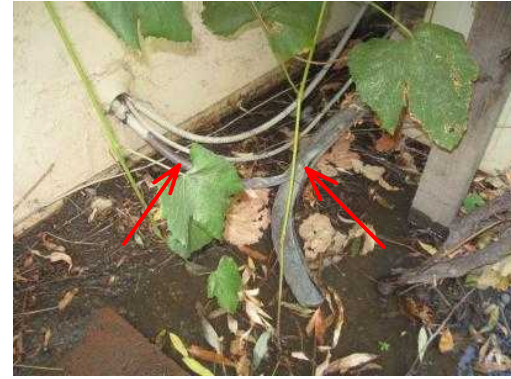
Missing insulation, at the low/high pressure lines. Replace insulation, as required.

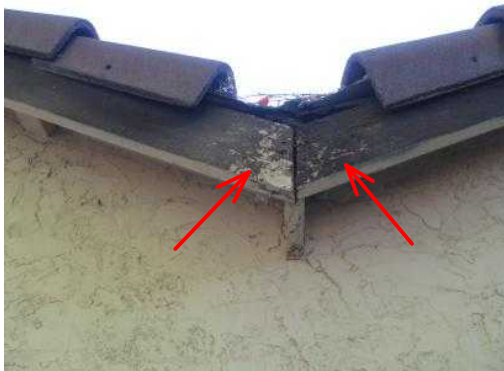
Wood deterioration noted to fascia/barge rafter, at right side of house, at the valley area.

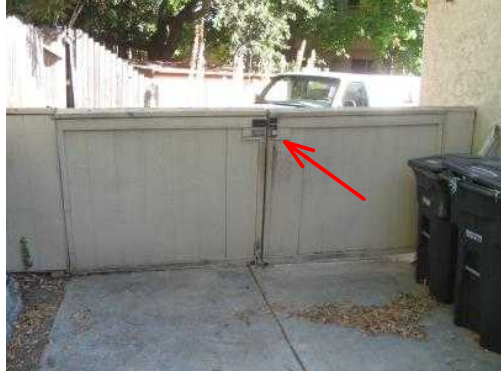
There is a pad lock on the right side gate. The gate was not tested.

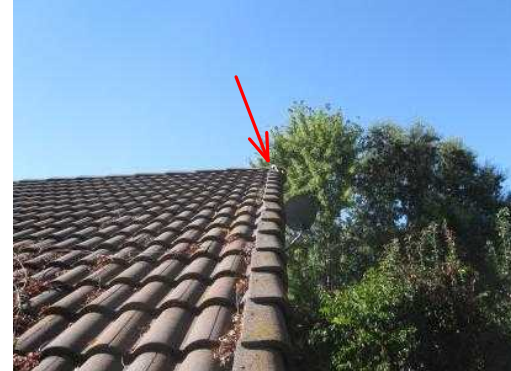
Left and right side end area ridge caps are missing/loose. Repair, as required.

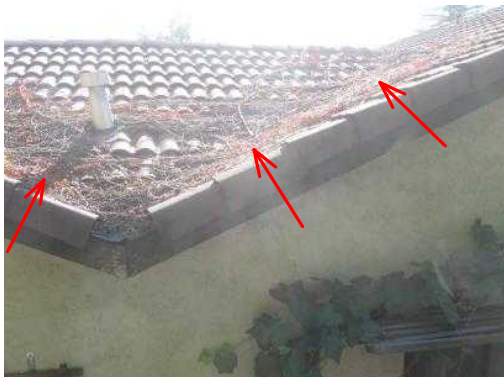
Debris located in metal valleys. Recommend cleaning the valley areas, for proper roof drainage.

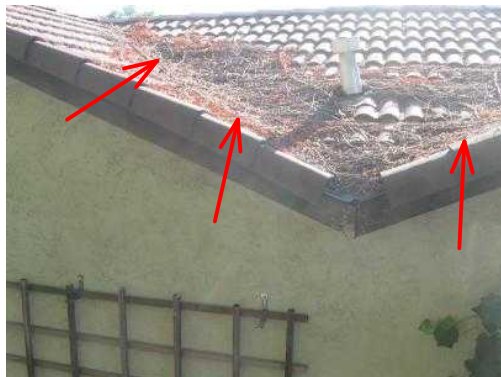
Debris located in metal valleys. Recommend cleaning the valley areas, for proper roof drainage.

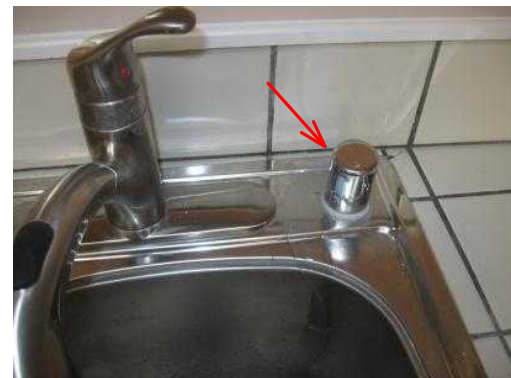
Dishwasher drains thru air gap. Clean drain line and re-test. Consult a licensed plumber.

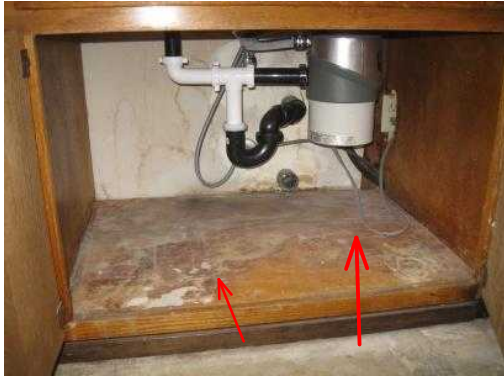
Evidence of prior leakage. Stain in kitchen sink base cabinet bottom. See pest report.

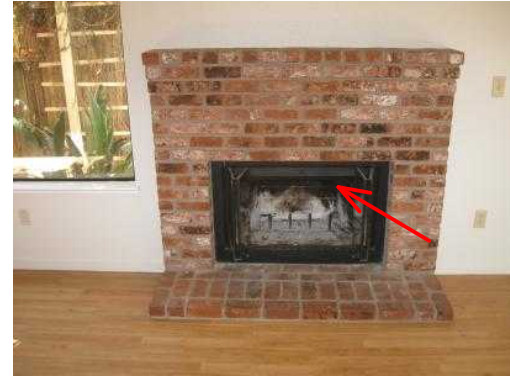
Creosote build-up noted. Have cleaned and liner re-checked, prior to use.

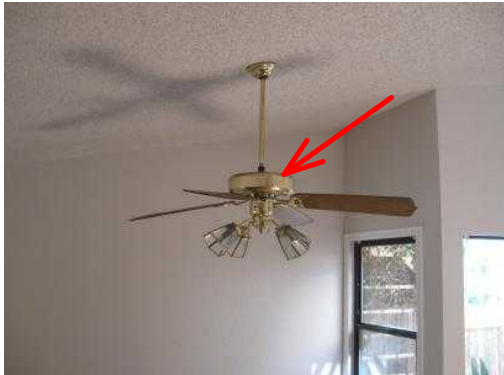
The dining room ceiling fan is out of balance. Correct, as necessary.

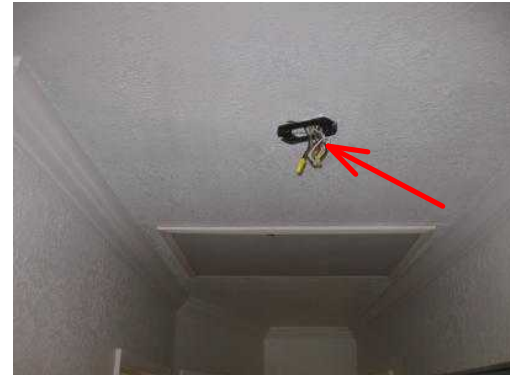
Missing hallway ceiling smoke detector unit noted. Replace, as required.

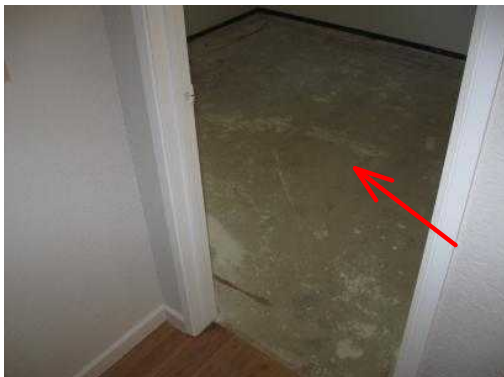
Missing right/front bedroom area flooring noted. Cracking noted at the slab.

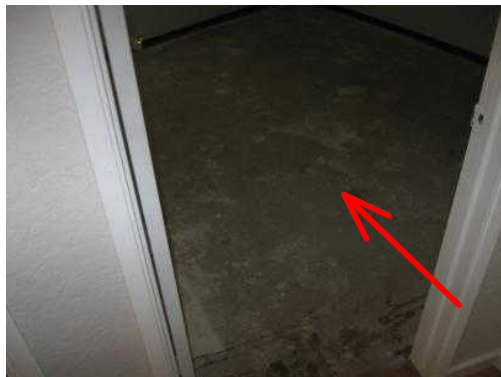
Missing right/middle bedroom area flooring. Cracking noted at the slab.

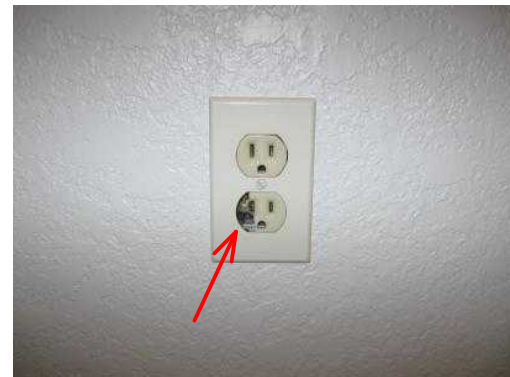
Broken right side/middle bedroom right side wall outlet. Consult a licensed electrician for repairs.

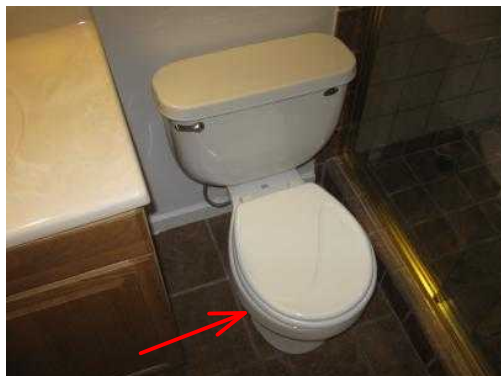
The hall bathroom toilet is loose at the floor and will require replacement of the wax seal.

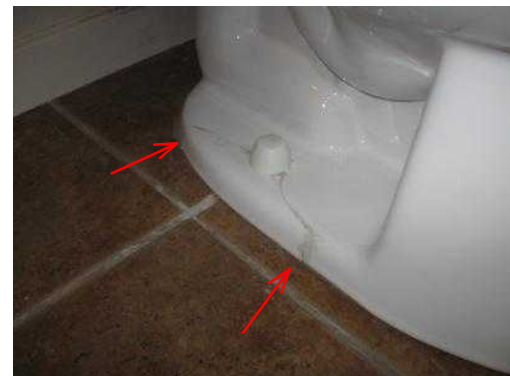
Crack noted at the left side base of hall bathroom toilet. Recommend replacing the toilet.

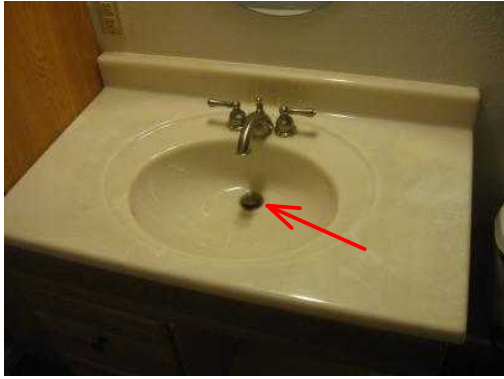
Leak at hall bathroom sink drain pipe/stop valve connection. Repair, as required.

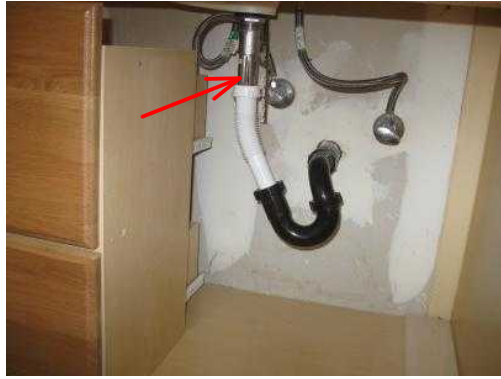
Leak at hall bathroom sink drain pipe/stop valve connection. Repair, as required.

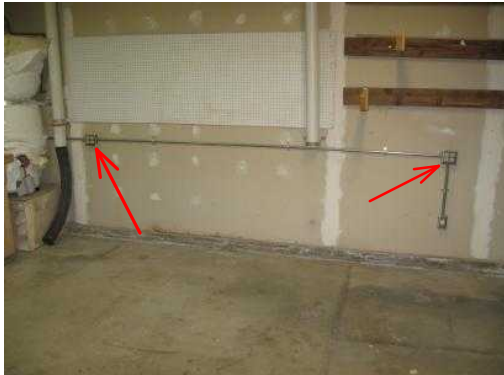
GFCI protection required at all added garage outlets. Safety Hazard.

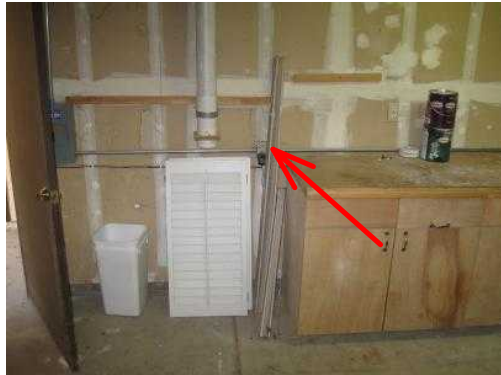
GFCI protection required at all added garage outlets. Safety Hazard.

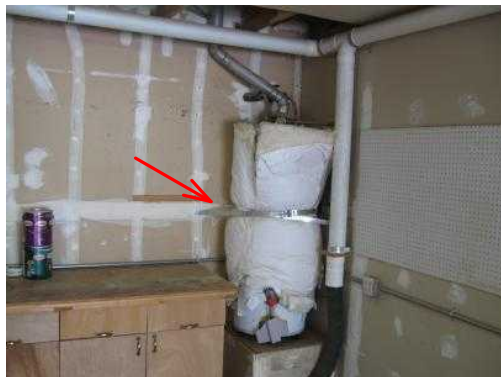
Water heater earthquake (seismic restraint) support straps missing or not properly installed.

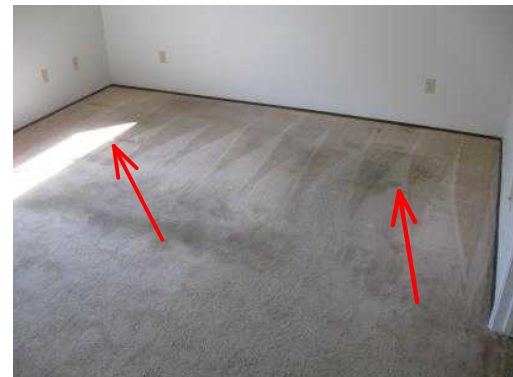
Stained/torn master bedroom carpeting noted. Replace, as desired.

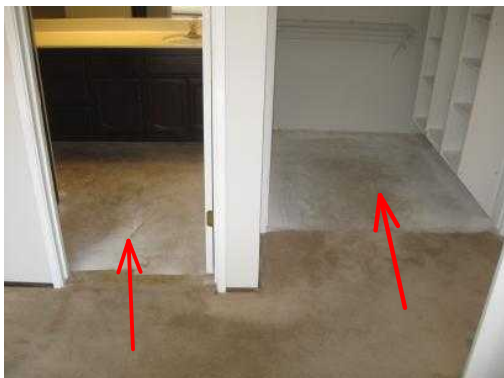
Missing master bedroom walk-in closet and master bathroom flooring noted.

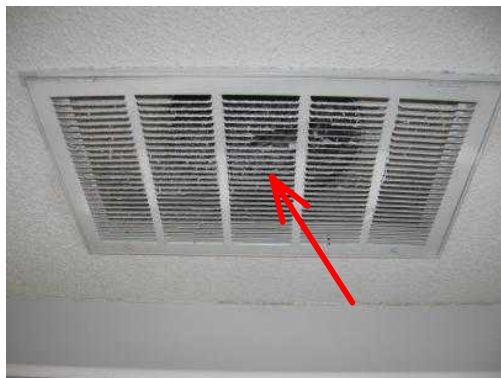
The filter is missing, at the master bedroom walk-in closet area ceiling cold-air return.

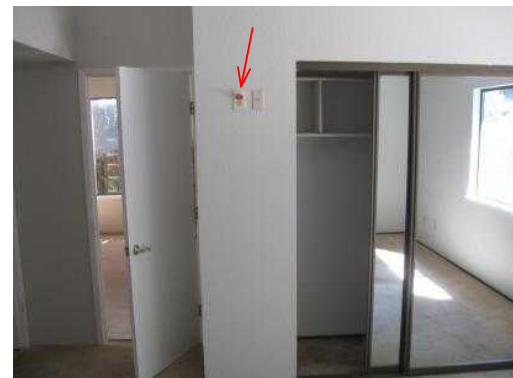
Reversed polarity, at master bedroom upper wall outlet, next to the bypass closet doors.

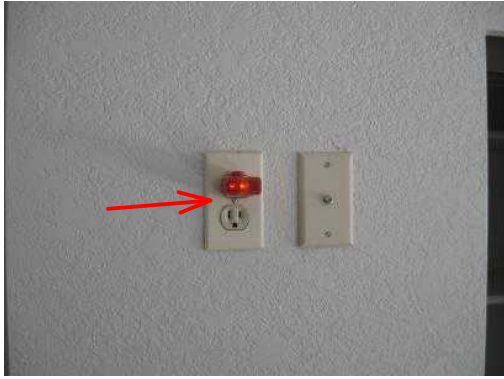
Reversed polarity, at master bedroom upper wall outlet, next to the bypass closet doors.

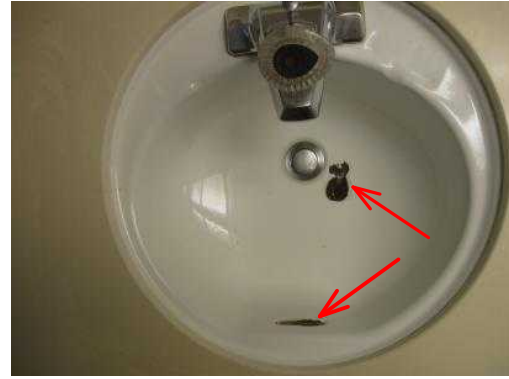
Rusting at the overflow drains and on the underside of master bathroom sinks.

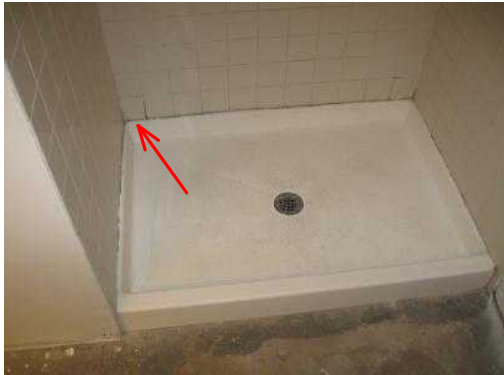
Grout needs work, at the bottom courses of master shower tile; repair, as required.

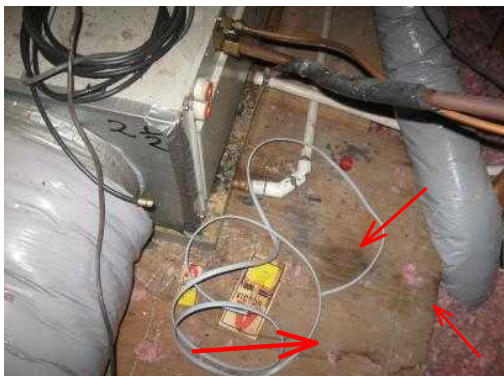
Water stains noted at the plywood base, under the heating unit in the attic. The area was dry, at the time of inspection. Refer to seller for disclosure.

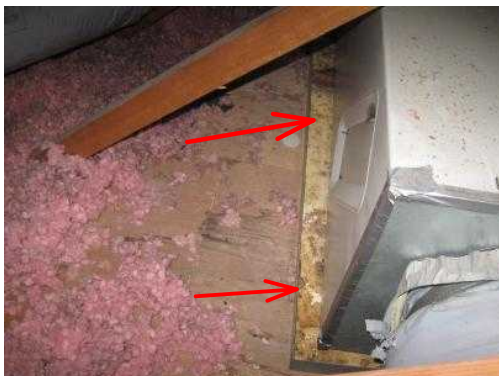
Refer to seller for disclosure. There is rusting noted in the overflow pan under the heating unit in the attic. Refer to seller disclosure. Consult a licensed HVAC contractor for evaluation and
