Inspector Name Jim Michelmores
Company Name JM's Home Inspections
Company Address 11637 Boom Pointer Way
City Gold River **State** CA **Zip** 95670
Phone 916-216-6612 **Fax** 916-635-1366
E-Mail jmichelmores@sbcglobal.net
File Number Sample report
Amount Received \$400.00 Through Escrow

Home Inspection Report

1234 Unknown Drive
Anywhere, CA 00000

Prepared for: John Doe

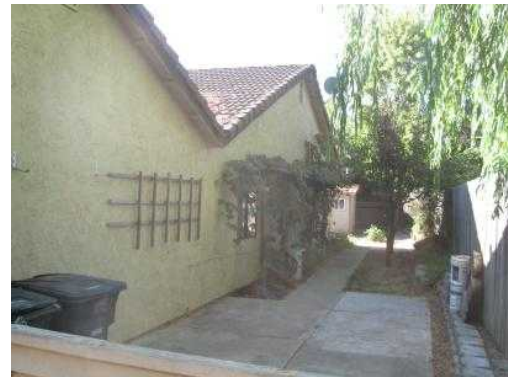
Shows a right side exterior view of the house.

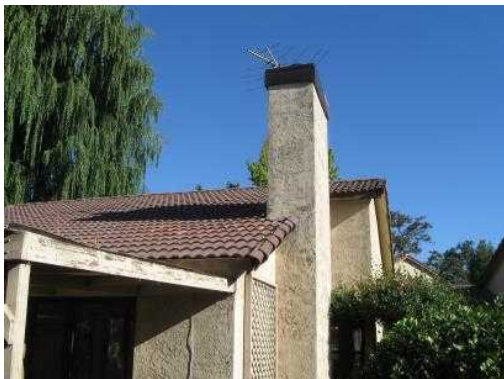
Shows a left side and rear exterior view of the house.

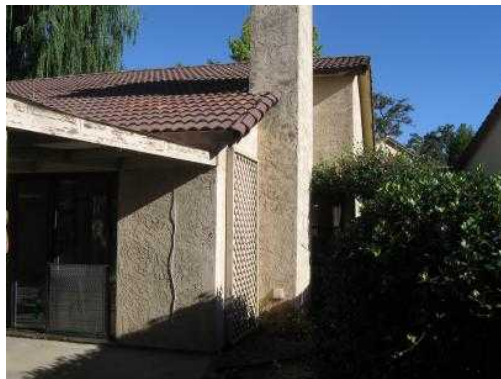
Shows a continued left side and rear exterior view of the house.

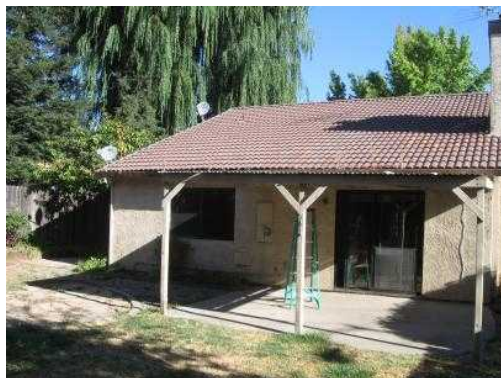
Shows a rear exterior view of the house.

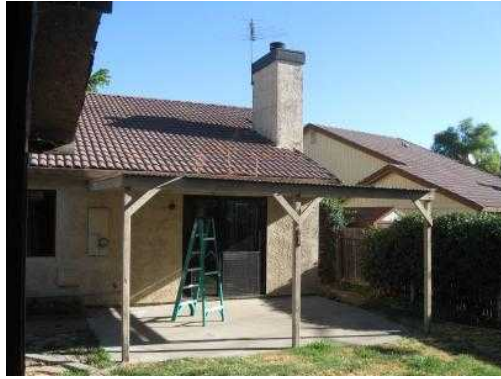
Shows a rear exterior view of the house and patio cover area.

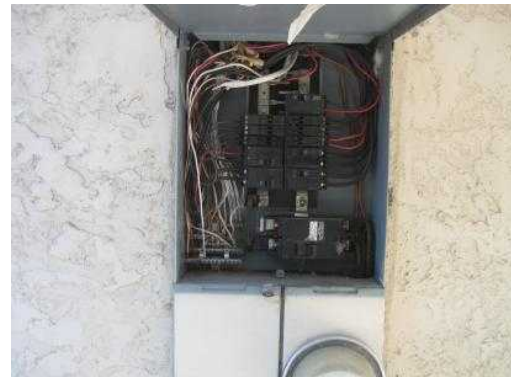
Shows the rear main electrical panel box, in good condition.

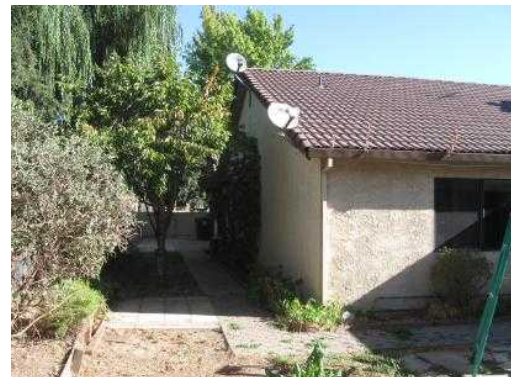
Shows a right side and rear exterior view of the house.

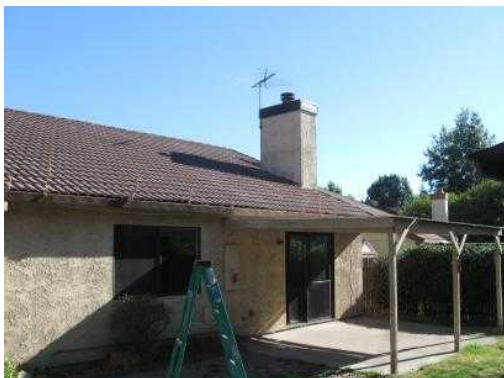
Shows a continued rear exterior view of the house and patio cover.

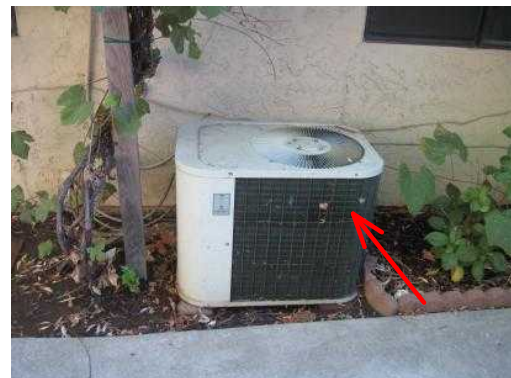
Functioning and serviceable. Anticipate repairs or replacement in future.

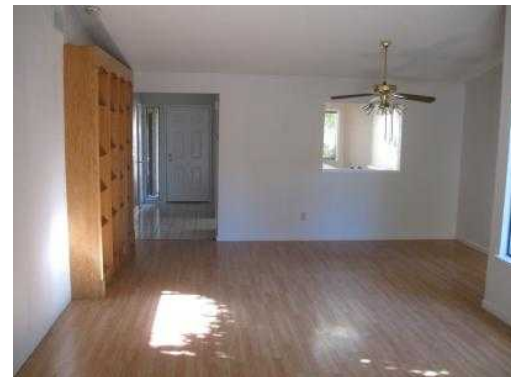
Shows view of the dining room and entry areas, as seen from the rear living room.

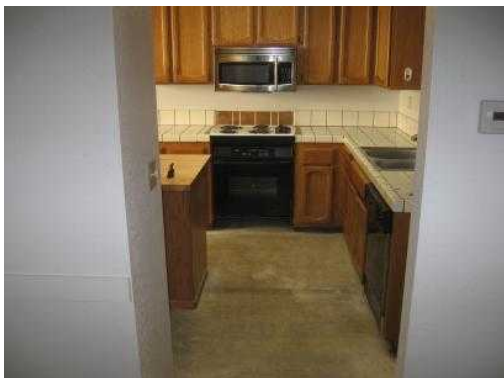
Shows view of the kitchen, as seen from the entry area.

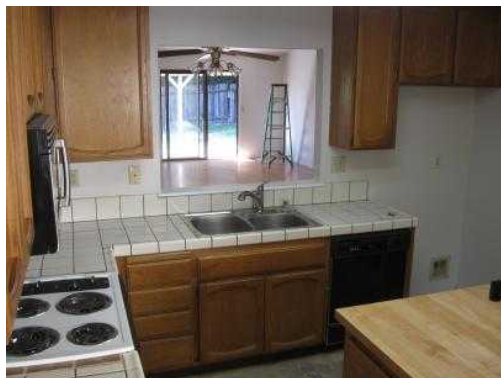
Shows view of the kitchen, as seen from the front nook area.

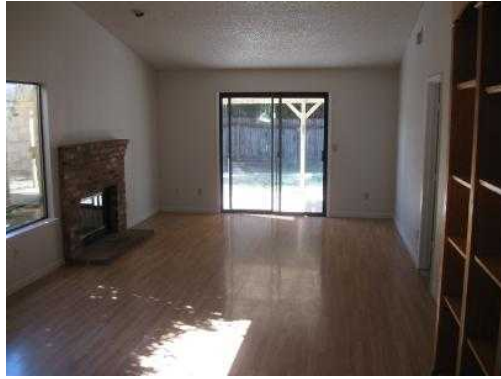
Shows view of the rear living room, as seen from the entry area.

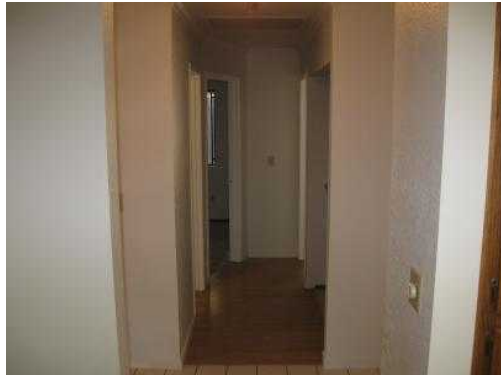
Shows view of the hallway, as seen from the kitchen.

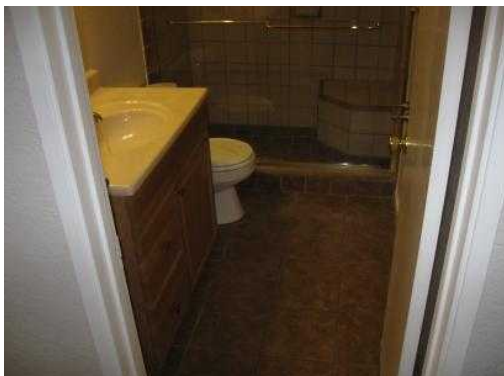
Shows view of the hallway bathroom.

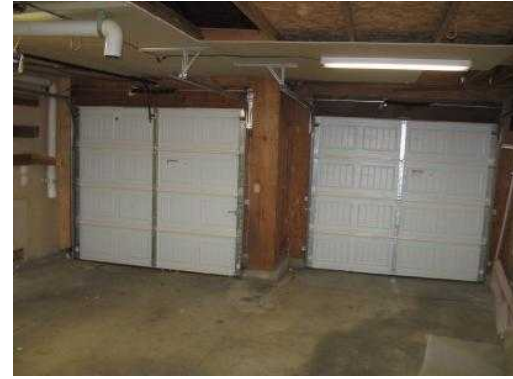
Shows an interior side view of the roll-up garage doors.

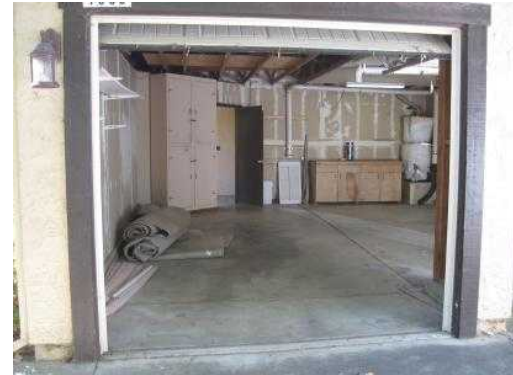
Shows an interior view of the garage.

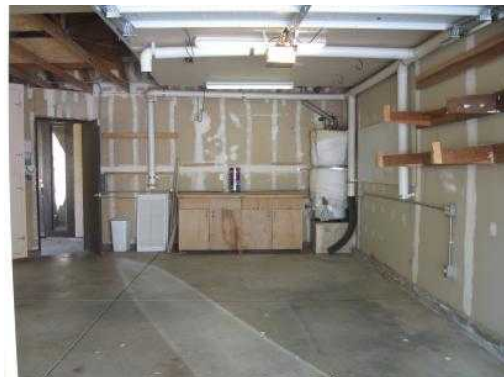
Shows an additional interior view of the garage.

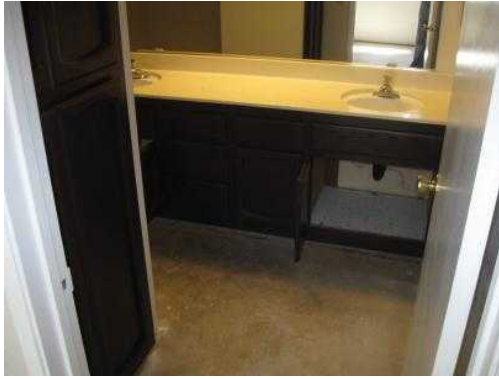
Shows view of the master bathroom vanity area.

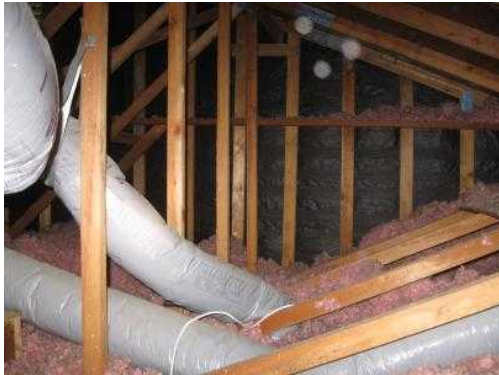
Shows a right side view of the attic space, in good condition.

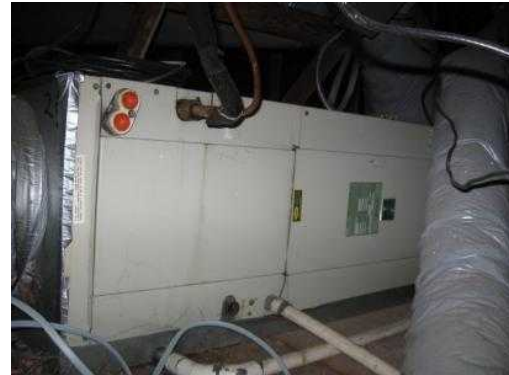
Shows view of the heating unit heat pump in the attic space. Original unit is 24 years old.

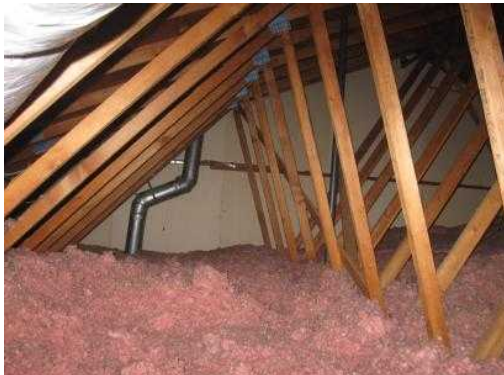
Shows a left side view of the attic space, in good condition.

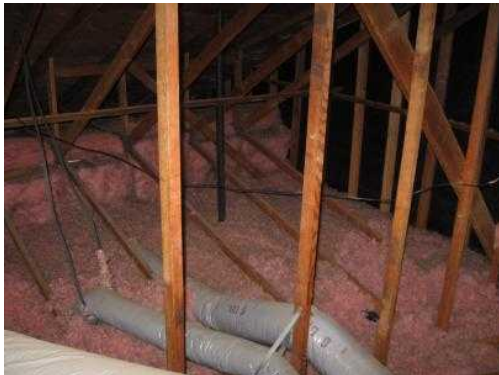
Shows a right/rear view of the attic space, in good condition.

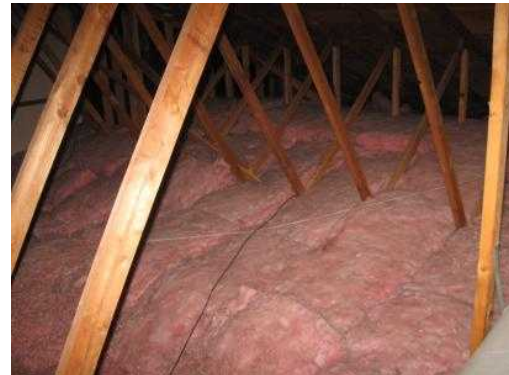
Shows a view of the attic space above the dining/living rooms, in good condition.
